1. Report No. NTSB/MAR-87/1		2. Government Accession No. PB87-916401		3. Recipient's Catalog No.	
4. Title and Subtitle Marine Accident Report—Capsizing and Sinking of the U.S. Sailing Vessel PRIDE OF BALTIMORE in the Atlantic Ocean, May 14, 1986				5. Report Date January 21, 1987

EXECUTIVE SUMMARY

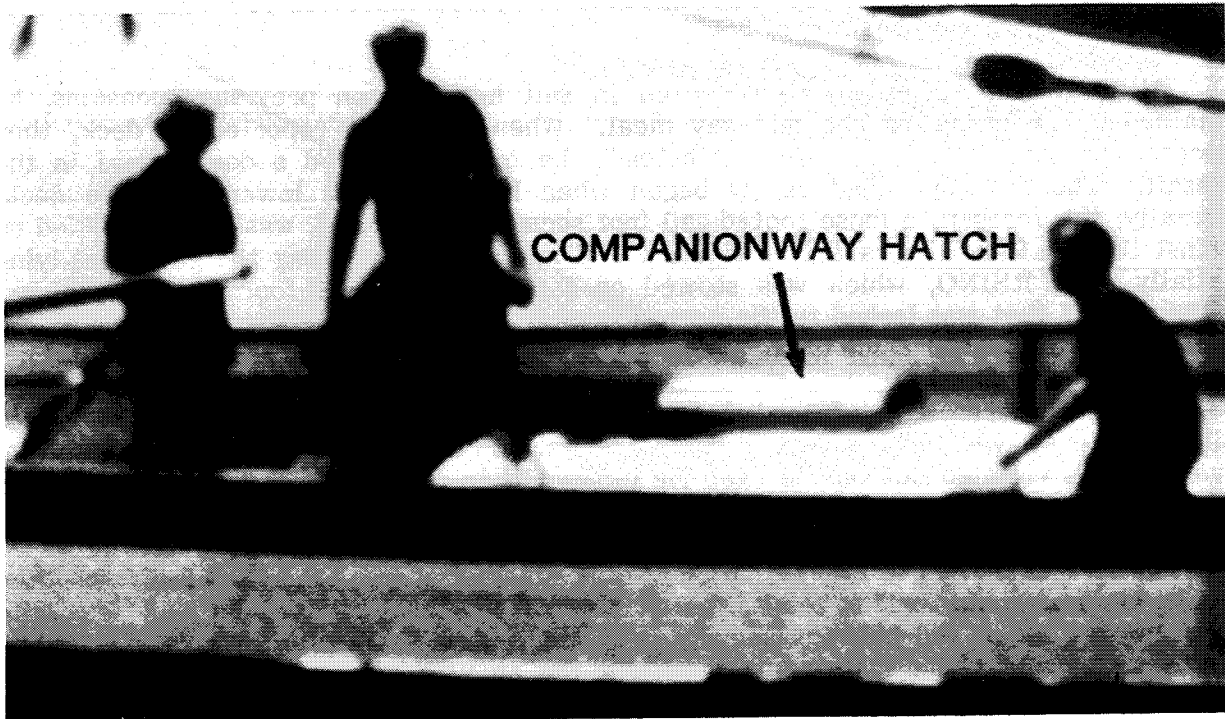
Figure 3.—Companionway hatch in main cabin trunk.

As the PRIDE heeled over to port, the crewmembers believed that it would right itself momentarily but when the more experienced crewmembers failed to detect any righting motion and observed that the open companionway hatch was underwater, they realized there was no possible chance for recovery. Because the hatch was located on the port side of the centerline, it was quickly submerged as the vessel heeled 90° to port. If the circumstances were reversed and the vessel heeled to starboard, the hatch would have been above the surface of the water and downflooding may not have occurred as rapidly. The PRIDE may have then survived the knockdown and recovered. It is not certain whether the heavy fo'c'sle hatch remained closed or swung open as the vessel heeled to 90° which would have contributed to the rapid downflooding.

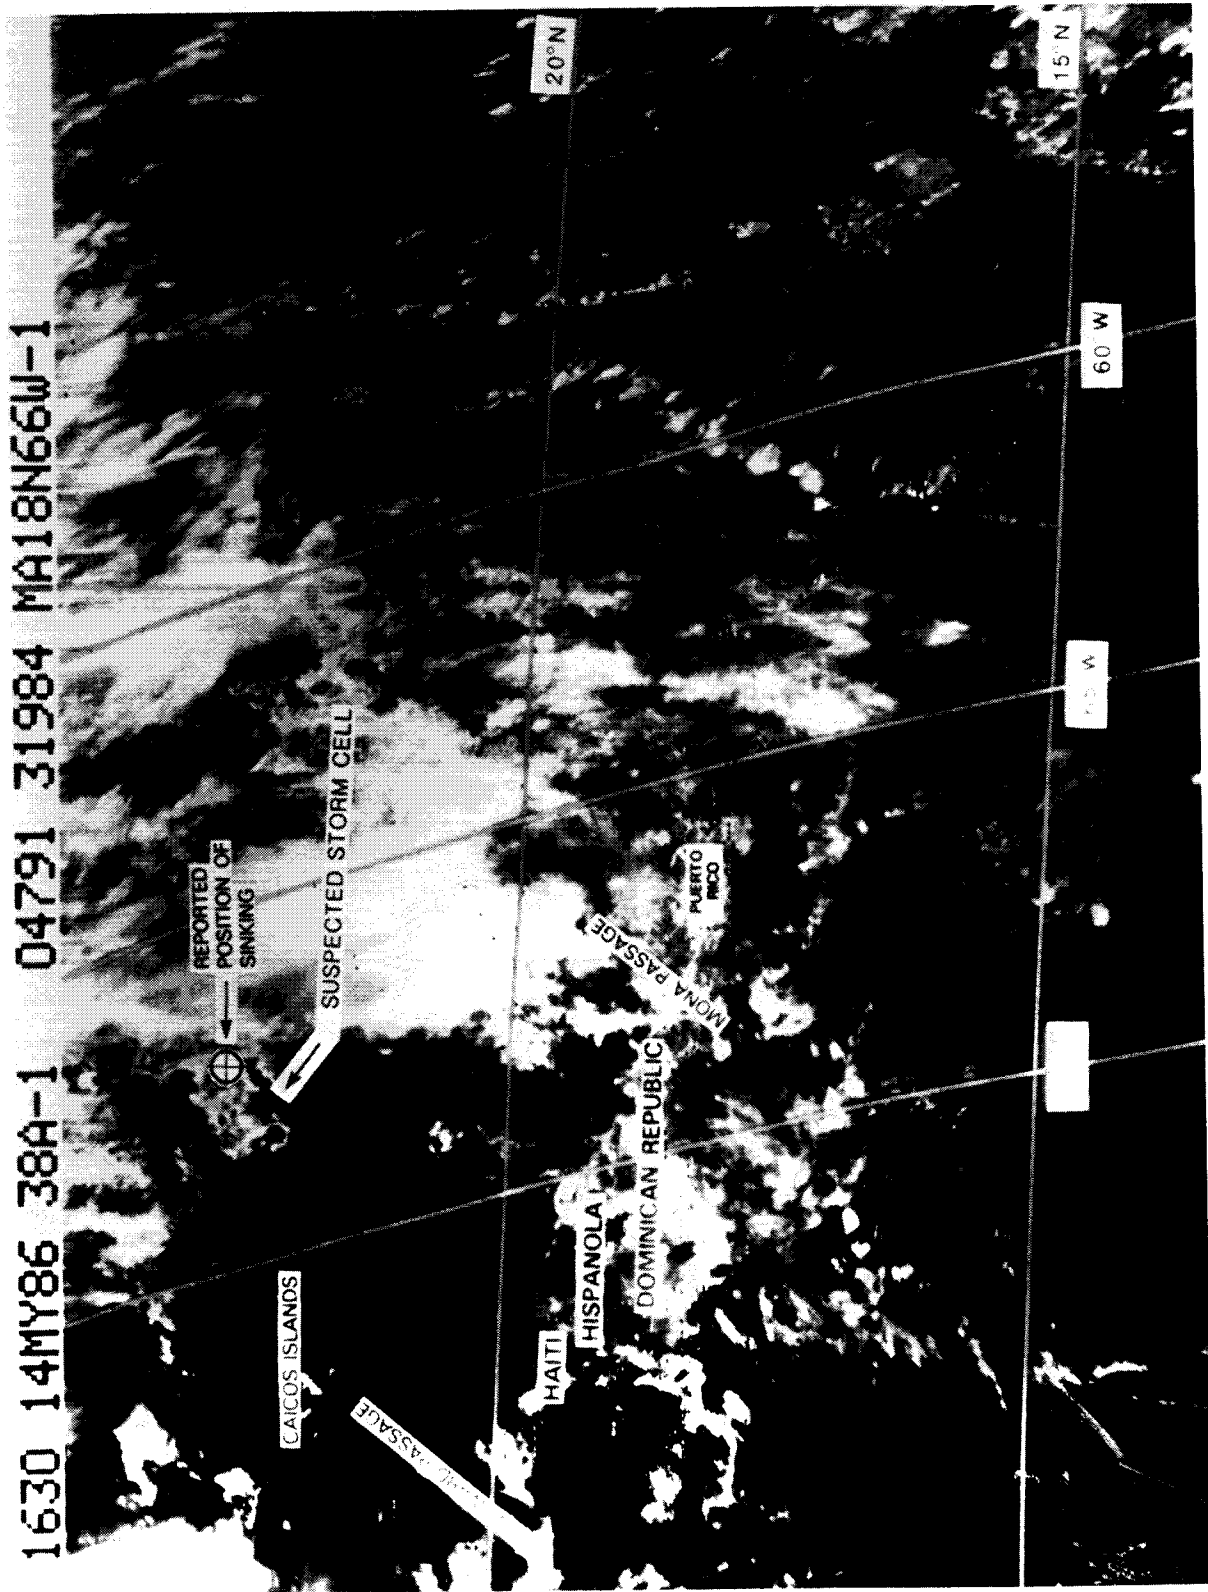
Figure 9.--Geostationary Environmental Operation Satellite visual light photograph taken at 1230 local time on May 14, 1986.

The 1230 enlarged GOES visual light photograph (see figure 9) showed cell structures in the vicinity of the accident that appear to indicate clouds developed on the periphery of a surface outflow from thunderstorms. Due to the uncertainty of the exact location of the PRIDE, it is not possible to determine which structure influenced the vessel.

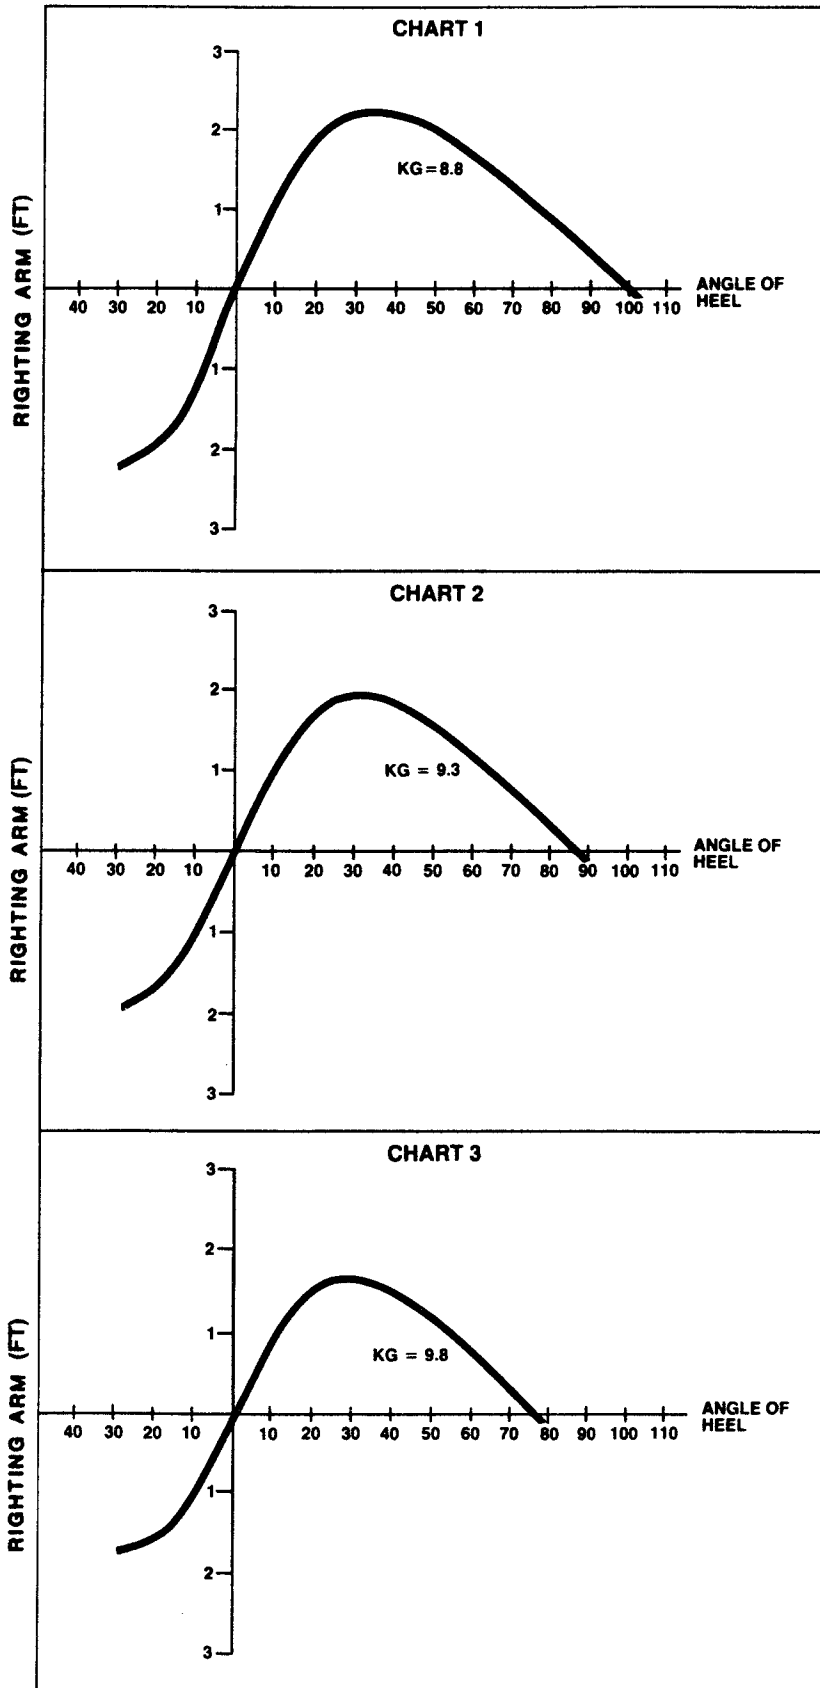
Figure 10.—Righting arm curves.

The study pointed out that a full suit of sails for the 122-ton PRIDE amounted to nearly 10,000 square feet of sail. By comparison, the Coast Guard's 1,816-ton training vessel EAGLE has 21,350 square feet of sail. The study showed that if its sails were reduced to the lower sails only, the PRIDE could have complied with the rules for passenger sailing vessels on partially protected waters, but not for ocean service. The study also showed that if its sails were further reduced to the forestaysail and a full mainsail and it had the lowest assumed KG (8.8 feet), the PRIDE could have complied with the rules for passenger sailing vessels for ocean service. With the sails in the same configuration as at the time of the accident, forestaysail and a double-reefed mainsail, the vessel still only would have met the passenger sailing ship criteria for ocean service if its KG was 8.8 feet or lower. Most Coast Guard certificated passenger sailing vessels are restricted to only the lower sails in order to comply with the regulations.

The study further states that under the new sailing schoolship regulations ^{37/}, the PRIDE, with all its lower sails set, could have been certificated as a sailing school vessel for ocean service if its KG was 8.8 feet or lower. With a foresail and a full mainsail or with the sails in the same configuration as at the time of the accident, a forestaysail and a double-reefed mainsail, the PRIDE would have met the sailing school vessel criterion for ocean service if its KG was 9.3 feet or lower. Under the same sail conditions in partially protected waters, the PRIDE would have met both criteria if its KG was 9.8 feet or lower, the three assumed values used in the Coast Guard study.

In the Coast Guard's stability study, it was pointed out that several assumptions had to be made to determine the "most likely" value for KG (9.3 feet) and displacement (122 long tons) at the time of the accident. A comparable GM of 6.1 feet derived from these values compared favorably with the minimum GM recommended by the designer. The study found that the KG values were critical to the operation of the vessel under Coast Guard standards for sailing vessels in ocean service. However, the Safety Board believes that should the PRIDE be replaced, its design should incorporate current Coast Guard standards for sailing vessels in ocean service. Therefore, based on the review of the

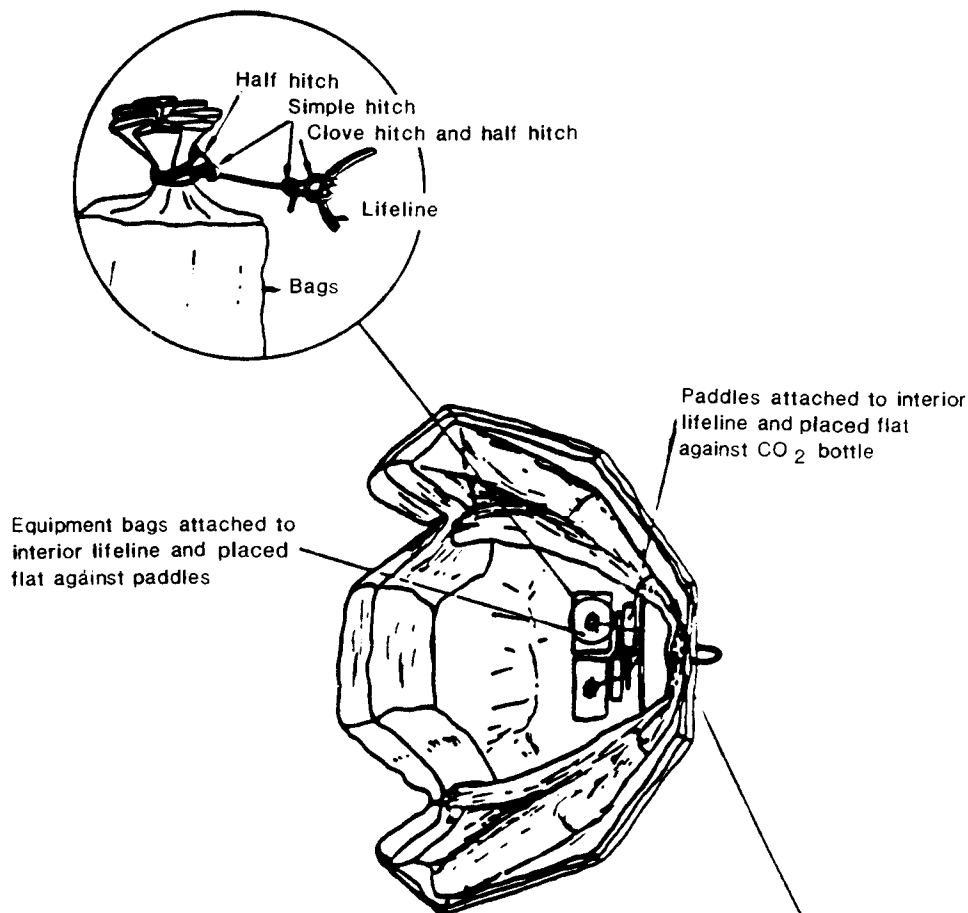
Figure 11.—Placement of equipment bags in liferaft.

The survival equipment and rations in the experimental raft were packed in a tied draw-string bag and securely tied to the interior of the raft to prevent loss, as described in the Zodiac Liferaft Manual. (See figure 11.)

When asked about the equipment bags that were secured in the rafts, the managing supervisor stated that after the contents were checked and replaced as necessary, the bags were cinched tight and tied at the bag before they were secured to the lifeline inside the raft. He believed that the only way the bags could come loose would be for the drawstring to break.

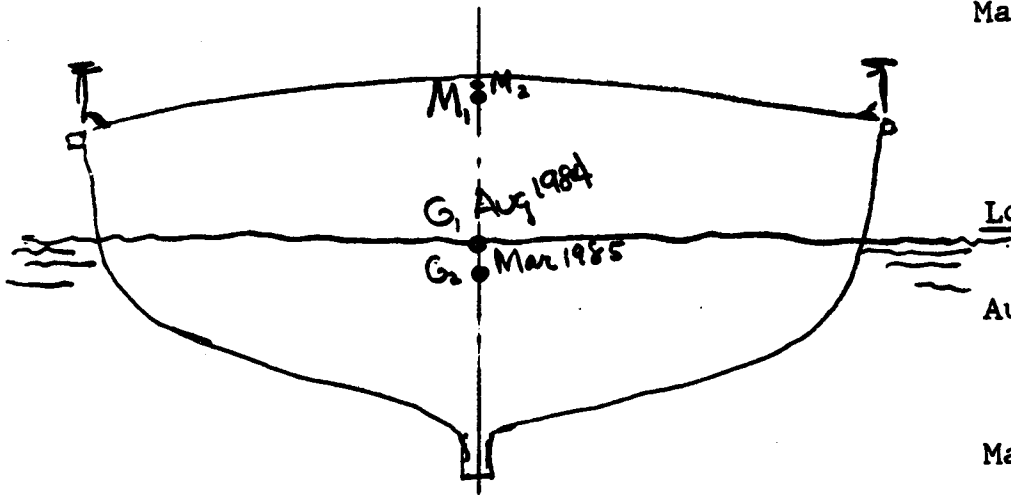
Aug '84, $G_1 = 9.75'$
 Mar '85, $G_2 = 8.84'$
