1. Report No. NTSB/MAR-87/1		2. Government Accession No. PB87-916401		3. Recipient's Catalog No.	
4. Title and Subtitle Marine Accident Report—Capsizing and Sinking of the U.S. Sailing Vessel PRIDE OF BALTIMORE in the Atlantic Ocean, May 14, 1986				5. Report Date January 21, 1987

EXECUTIVE SUMMARY

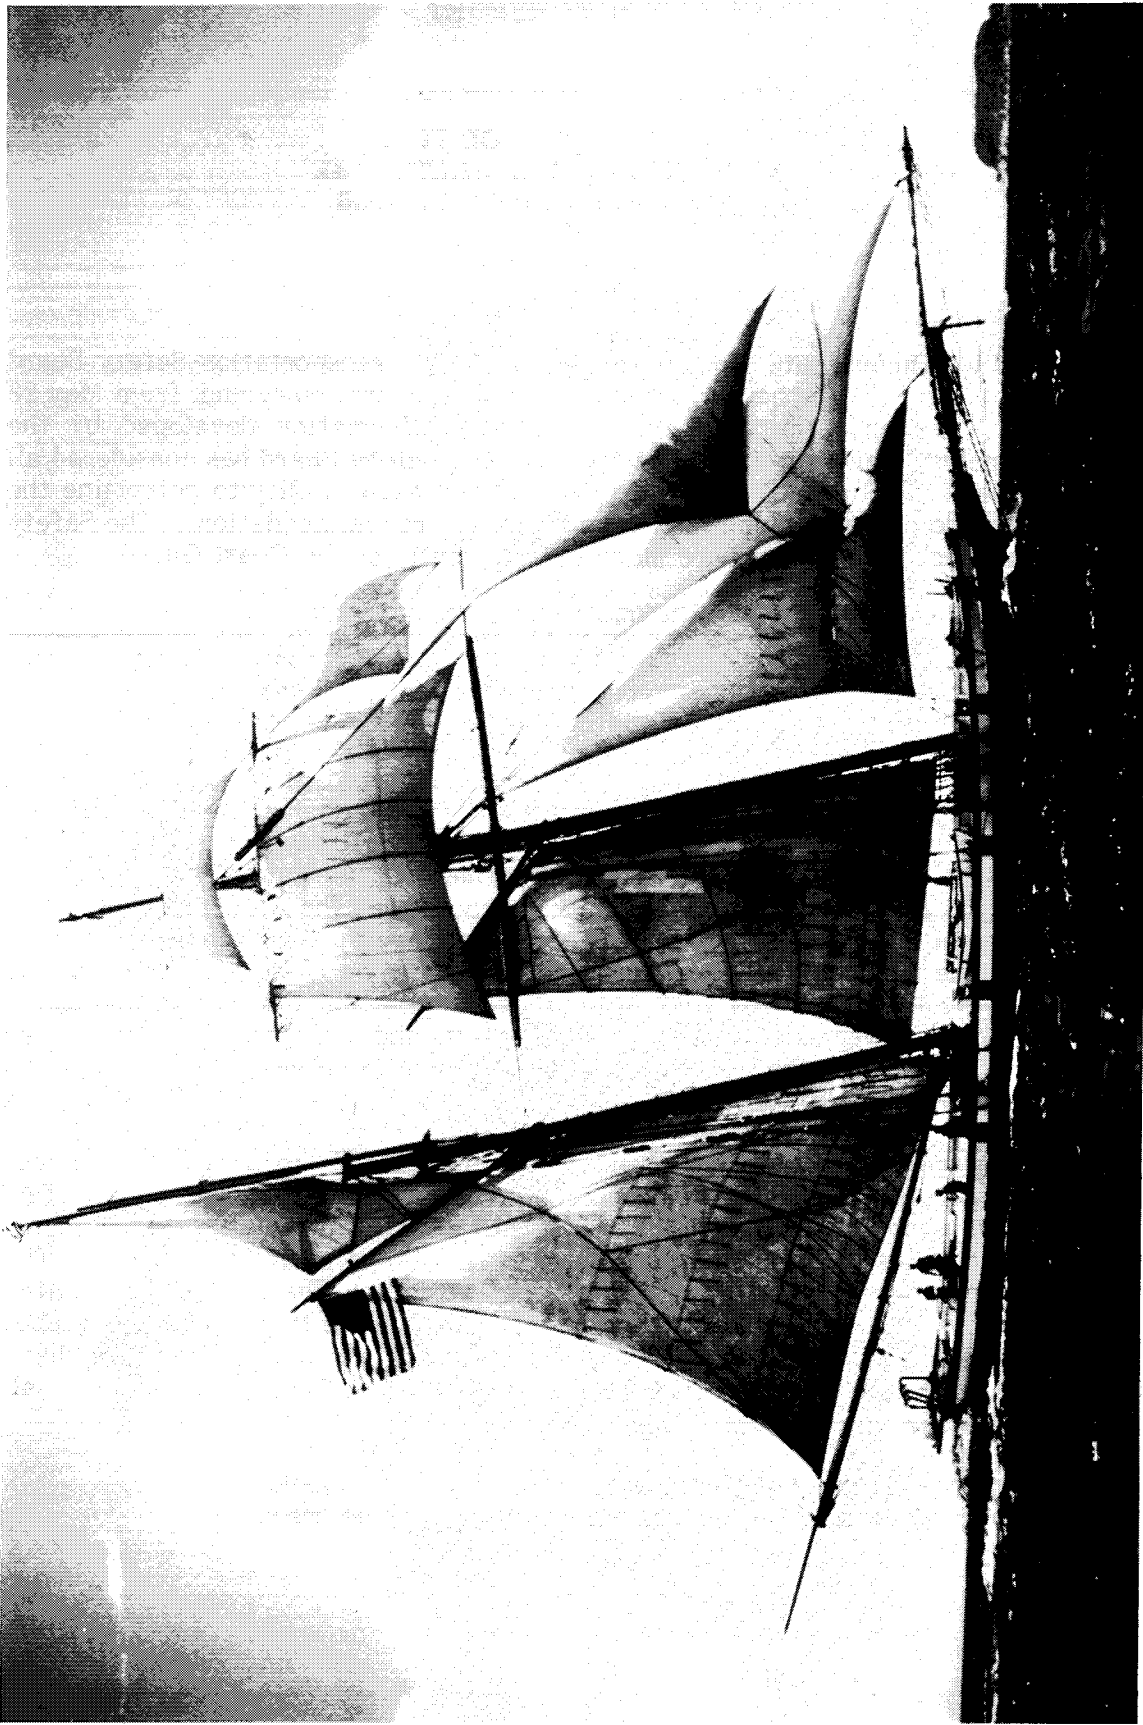
Figure 1.—PRIDE OF BALTIMORE
(Photographed by a crewmember on May 7, 1986.)

Construction.--The PRIDE was a two-masted topsail schooner that carried five lower working sails and could rig an additional six sails (see figure 2), which included the fore topsail, top gallant, stunsail, fisherman, main topsail, and the ringtail. (Figure 1 shows the PRIDE with each of these sails set except for the fisherman and ringtail.)

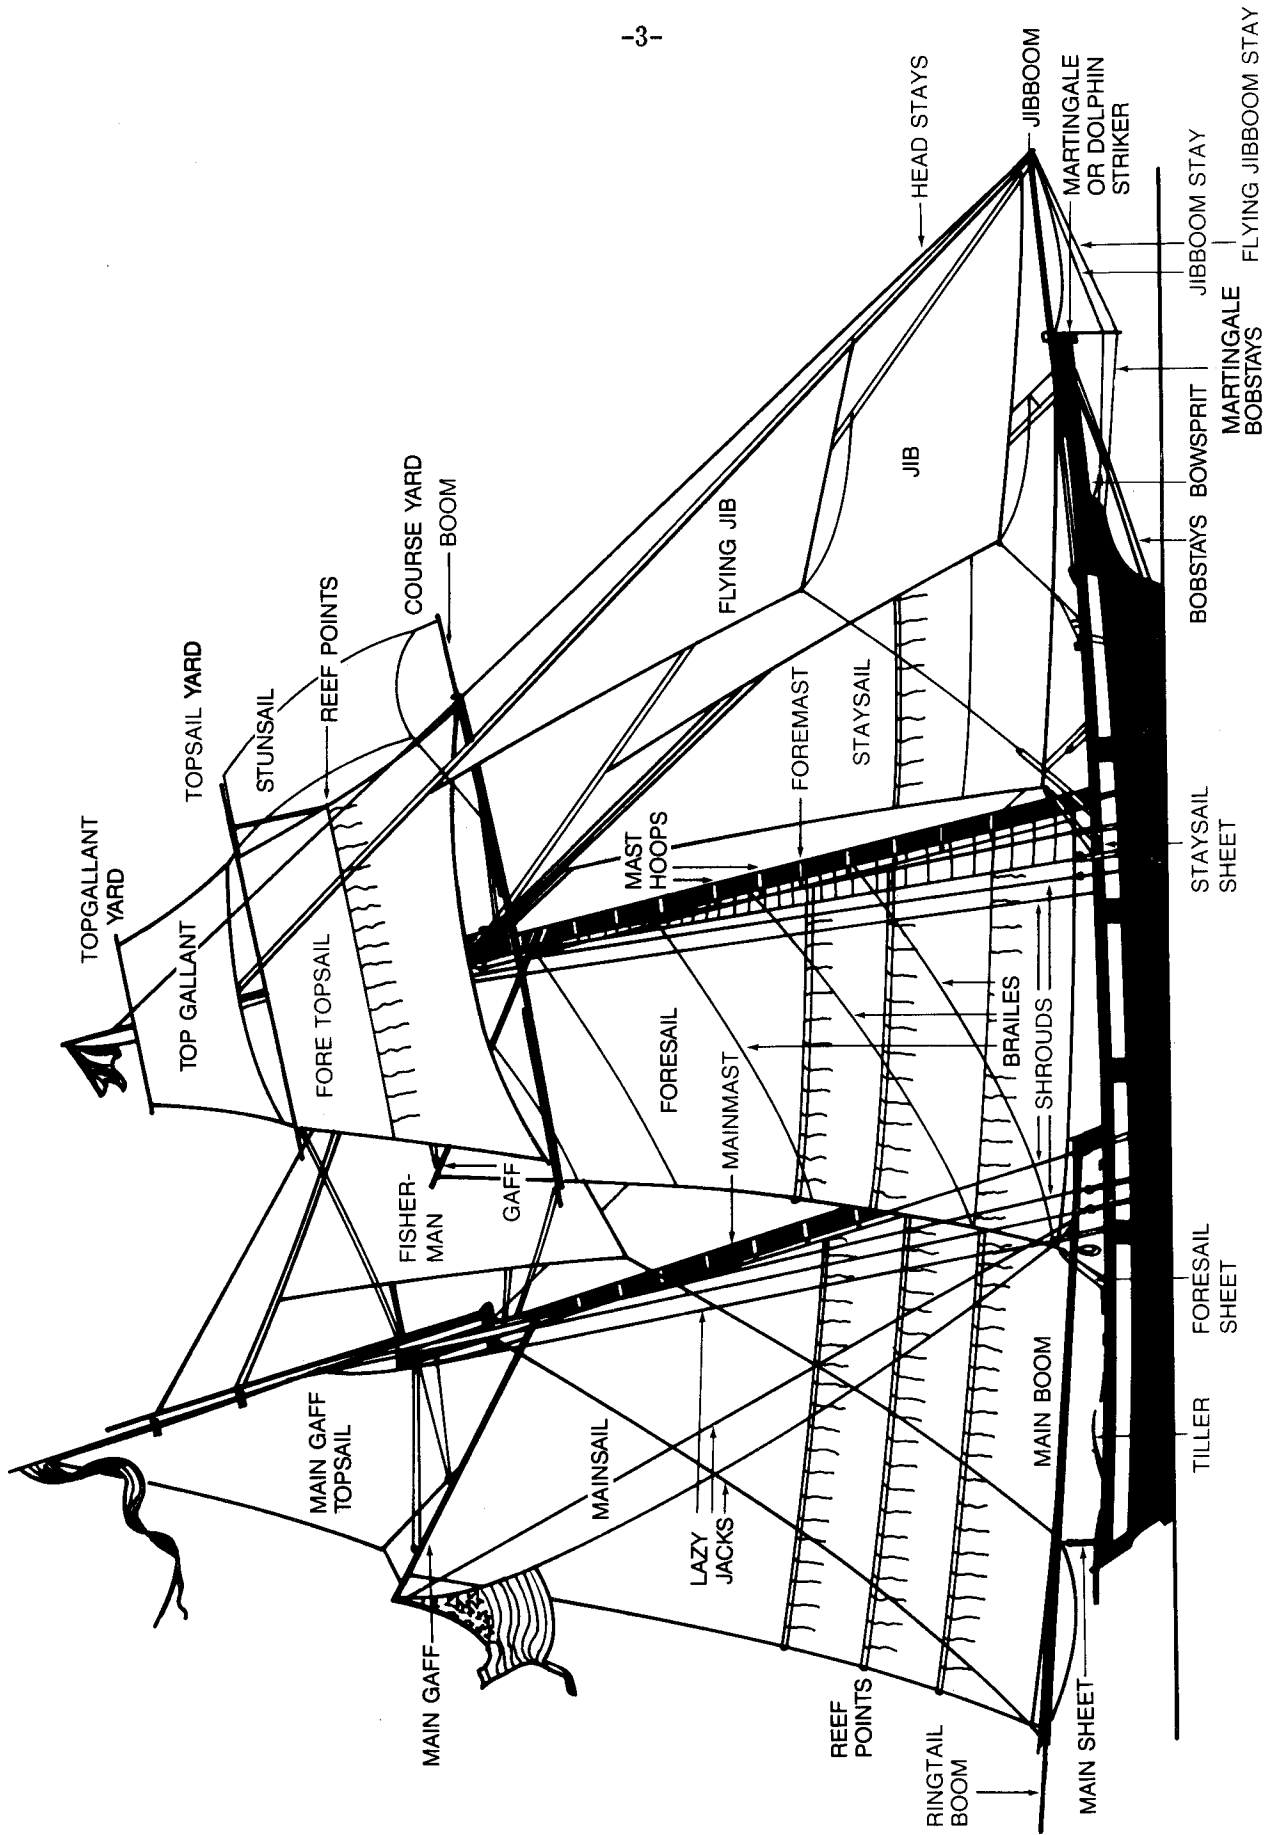
Figure 2.—Sail plan of the PRIDE OF BALTIMORE.

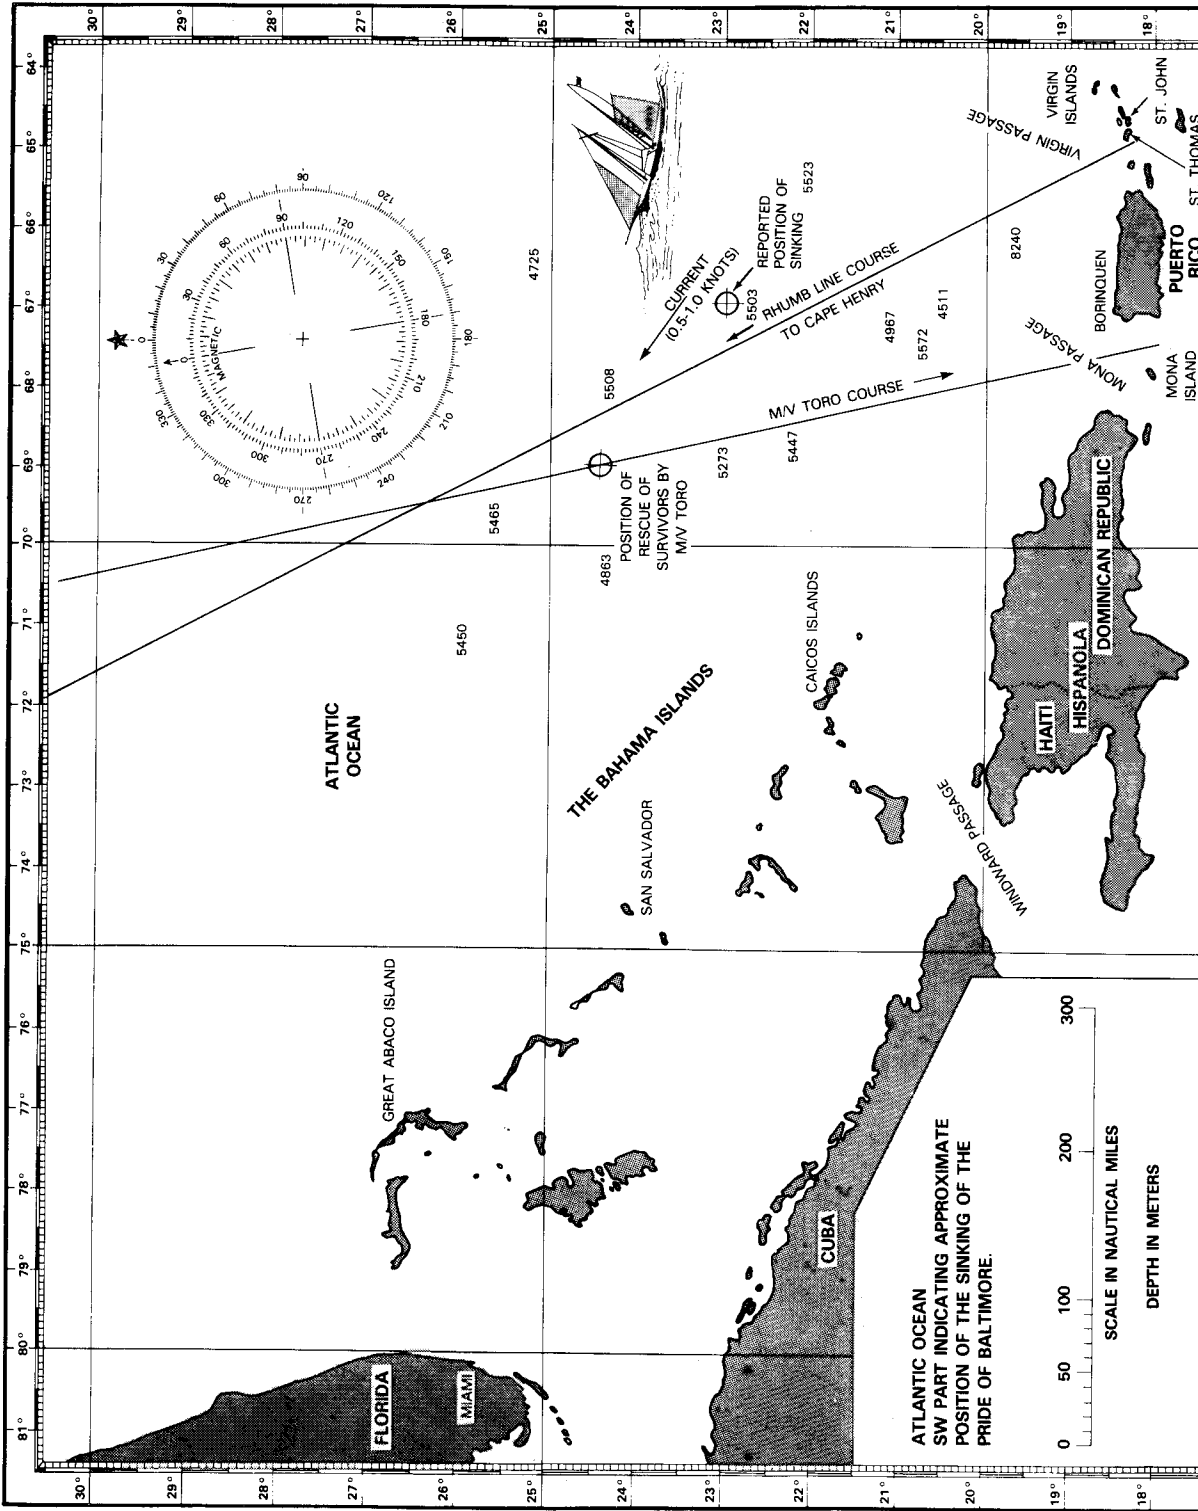
The PRIDE flooded through the open companionway hatch. It rolled over to port in less than a minute in a slow easy fashion and never recovered. As the vessel sank, it righted itself so that the masts were upright as they disappeared beneath the surface. The survivors made various estimates which ranged from less than 1 minute to as much as 5 minutes on the length of time it had taken the vessel to flood and sink. About 1230 on May 14, 1986, the PRIDE OF BALTIMORE disappeared from sight in an approximate position of 23° north latitude and 67° west longitude (see figure 4).

Figure 4.—Chart of the Atlantic Ocean showing the approximate position of the sinking of the vessel and the position of the rescue.

gave the order to steer towards the flashing light which was about 2 miles away. When the master determined that the light was coming from a liferaft, he stopped his vessel and ordered the TORO's rescue boat launched. After the eight survivors were taken aboard the rescue boat, the liferaft was slashed and allowed to sink. By 0300, the eight survivors were safely aboard the TORO and the rescue boat was hoisted back aboard. The TORO got underway again headed for Amuay Bay, Venezuela, via the Mona Passage.^{17/} The position of the rescue was latitude 24°26'06" N and longitude 69°01'07" W, about 370 miles north-northwest of Puerto Rico. (See figure 4.)

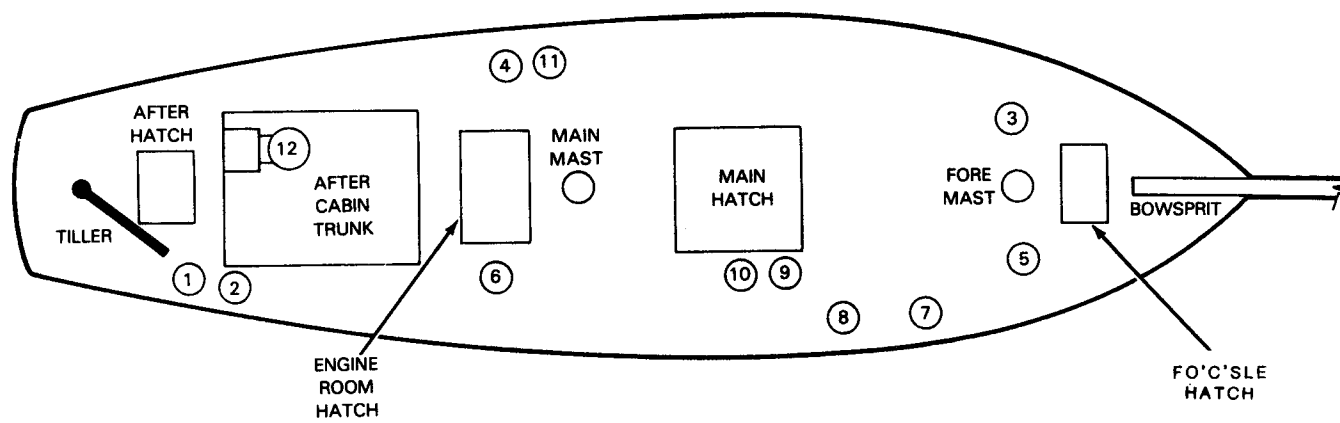
Immediately prior to the knockdown 11 of 12 crewmembers were on deck. Four deckhands were on the starboard side between the mainmast and the foremast; the second mate was on the port side near the foremast; the carpenter was on the starboard side near the foremast; a deckhand and the bos'n were on the port side near the engineroom hatch; the engineer was on the starboard side of the engineroom hatch; the cook was below deck in the aft cabin near the companionway ladder; and the first mate was at the stern with the master, who was steering the vessel. (See figure 5.)

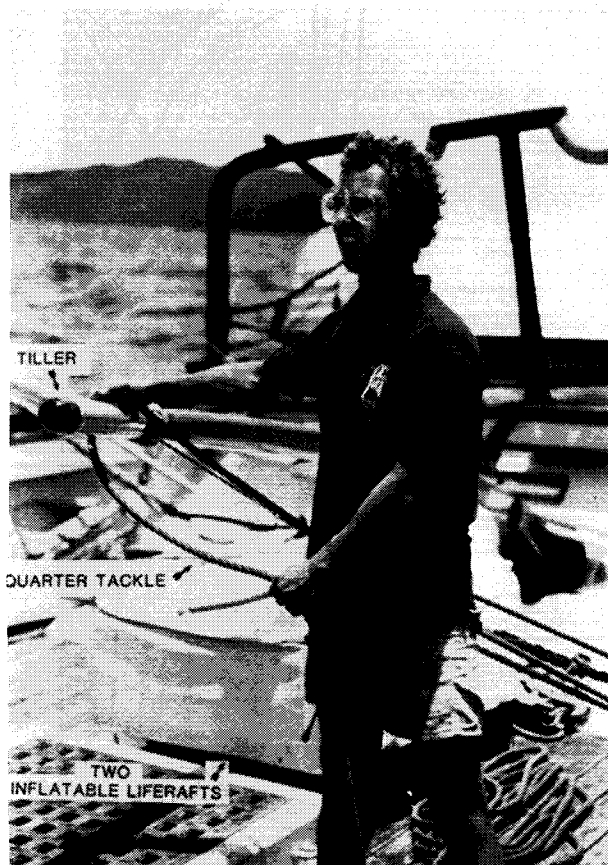
The rudder was controlled manually from aft by a 7-foot long tiller. When necessary the helmsman used quarter tackle (block and tackle) 23/ on the tiller when necessary to provide additional mechanical advantage to move the rudder. (See figure 7.)

Figure 7.--Helmsman steering with tiller and quarter tackle.

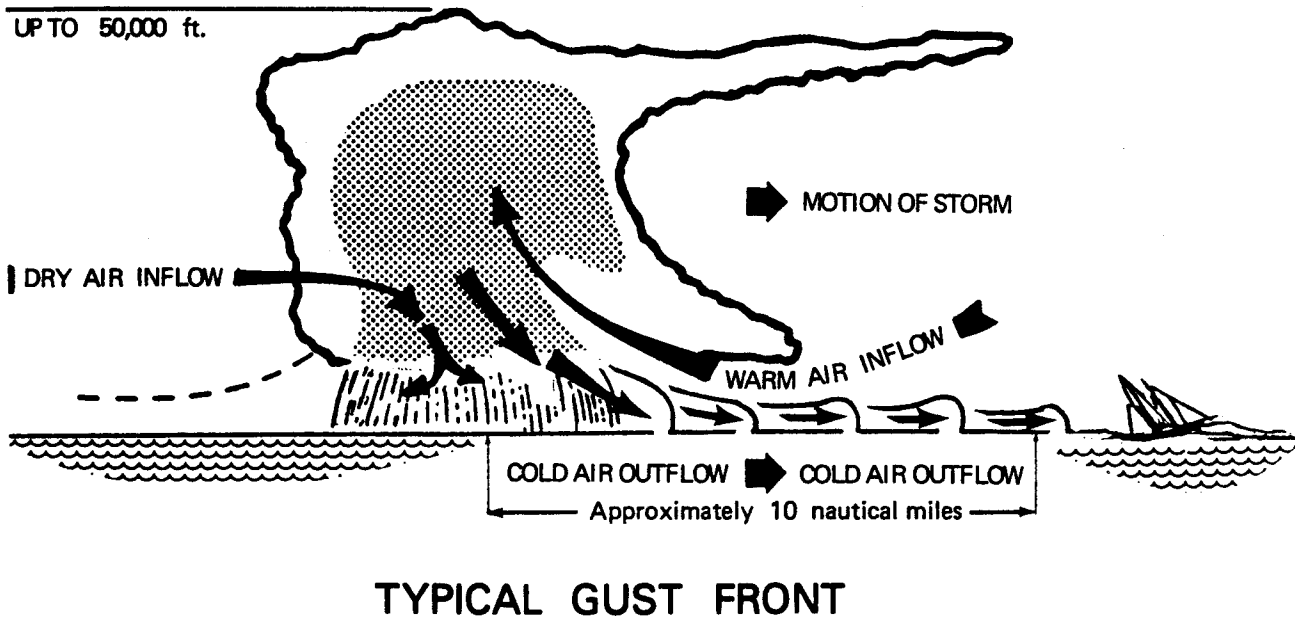
The PRIDE encountered a sudden onset of high winds or gust front (see figure 8) which heeled it over on its beam. The National Weather Service (NWS) surface weather analysis near the time of the accident showed a surface trough of low pressure oriented northeast-southwest in the vicinity of the accident and satellite photographs indicated thunderstorms in the area.

Figure 8.—Typical thunderstorm gust front.
